**Коригування роботи рятувальників при  
ліквідації наслідків влучання ворожого БпЛА  
в об'єкт «Укриття-2»**

# Основні характеристики Нового Безпечного Укриття (НБУ) "Укриття-2"

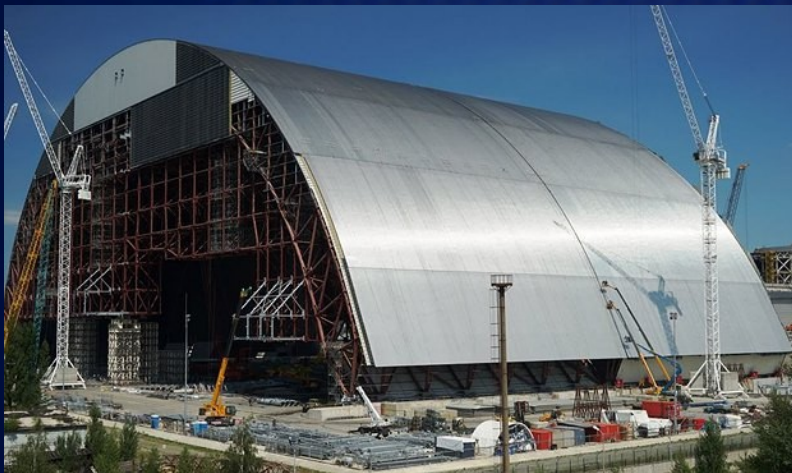
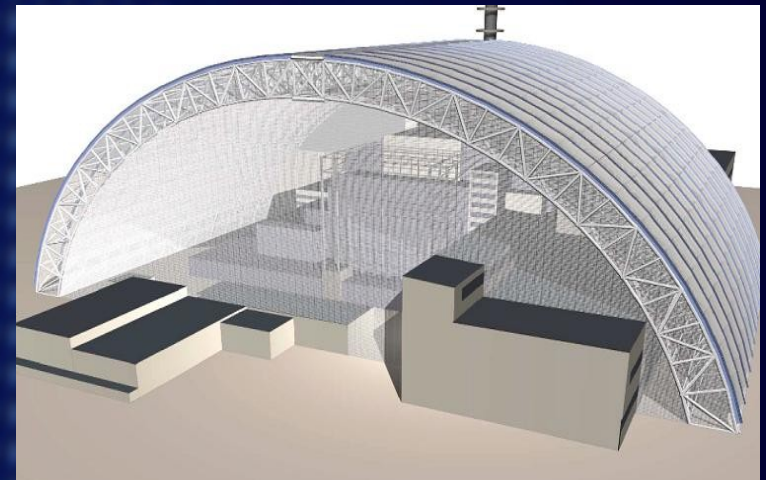
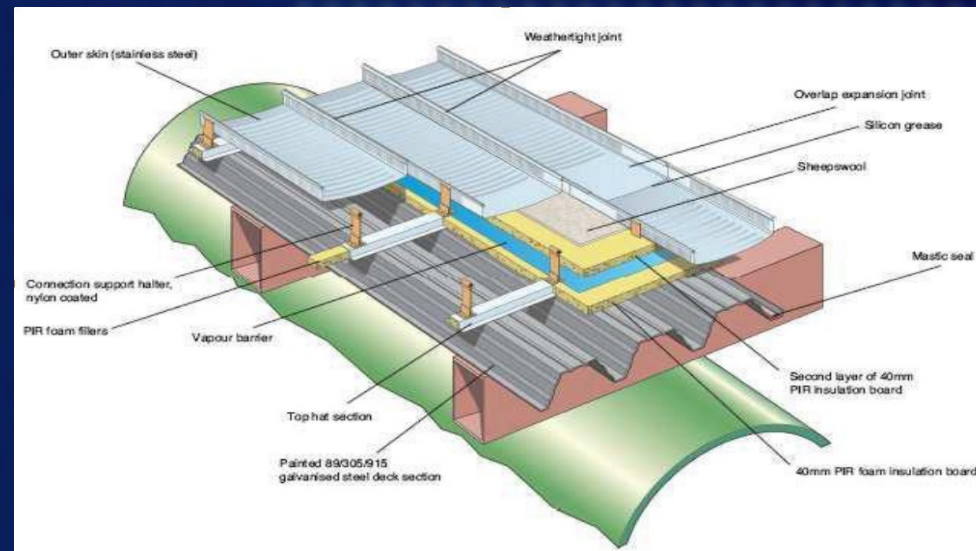
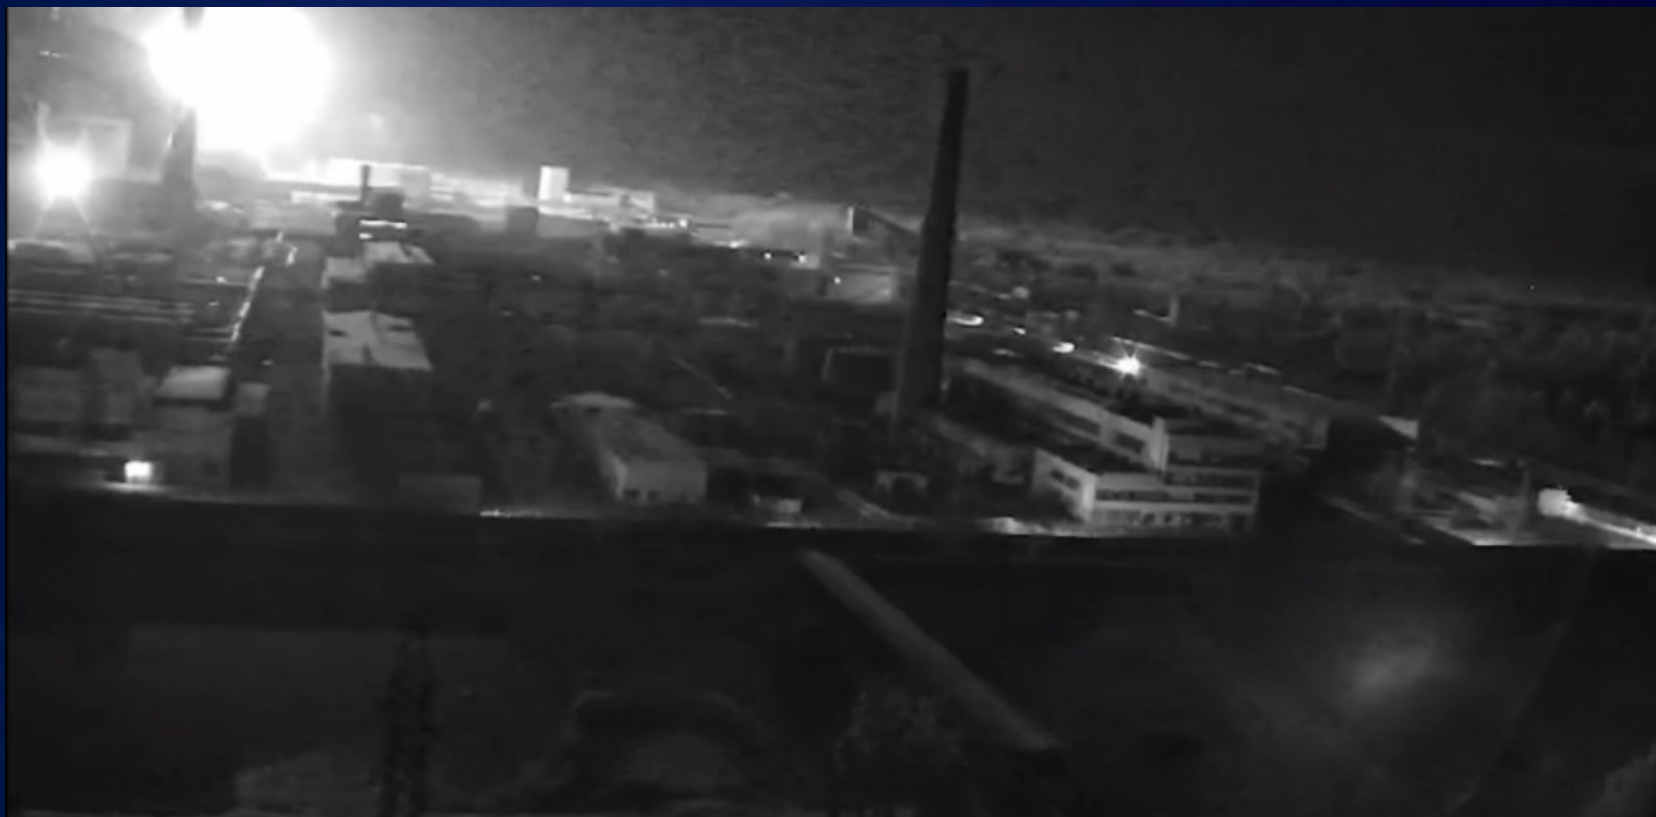
**14 лютого 2025 року 02:08 ДСП ЧАЕС внаслідок влучання БпЛА (Герань-2) у комплекс “Укриття-2”, виникло загорання мембрани на висоті 87 м між металевим покриттям та утеплювачем. Відбулося розповсюдження тління мембрани під металевим покриттям.**

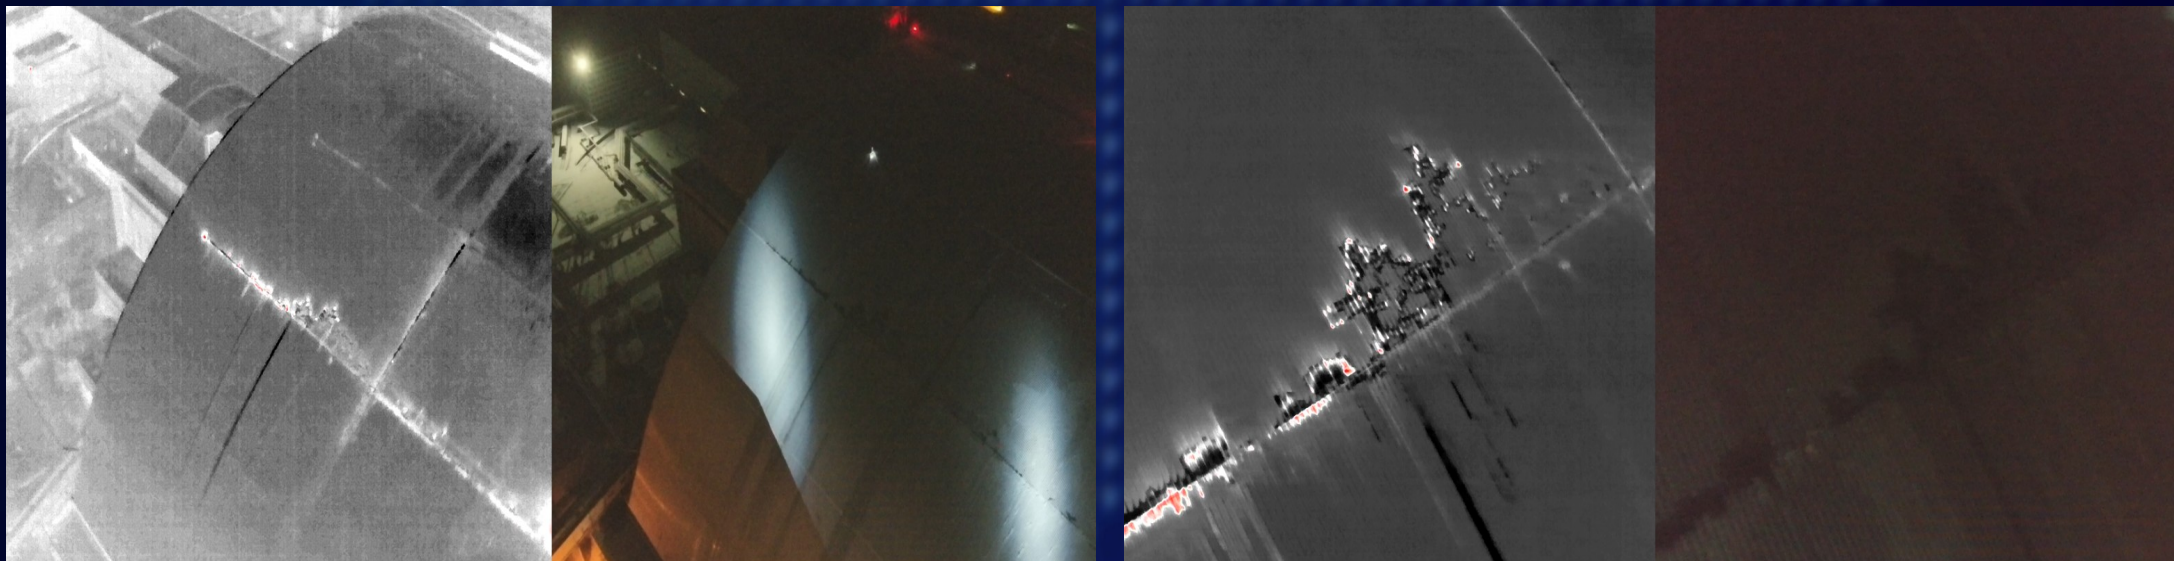
- Проведення розвідки та моніторинг розвитку пожежі

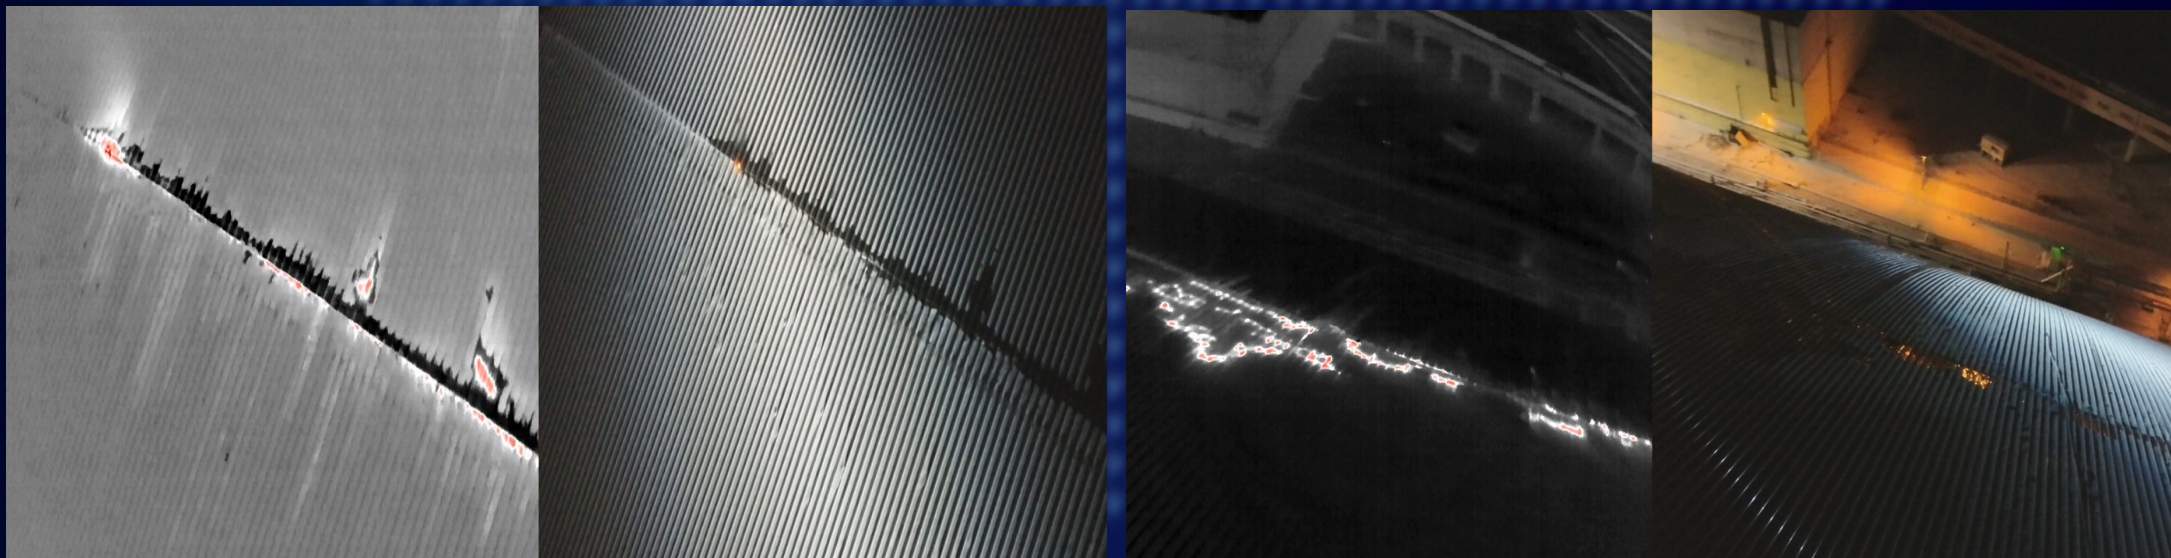
- Виявлення осередків тління

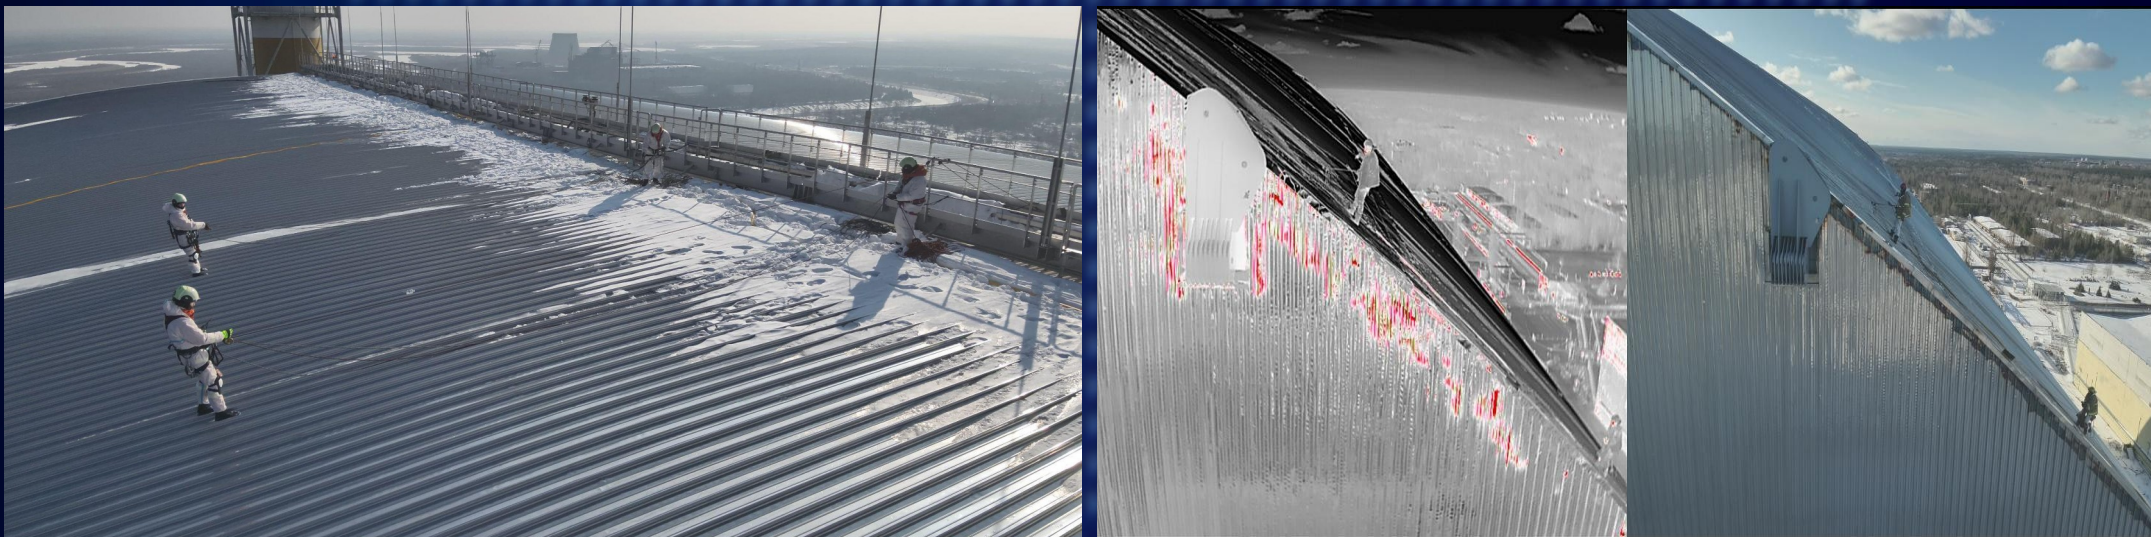
- Коригування рятувальників

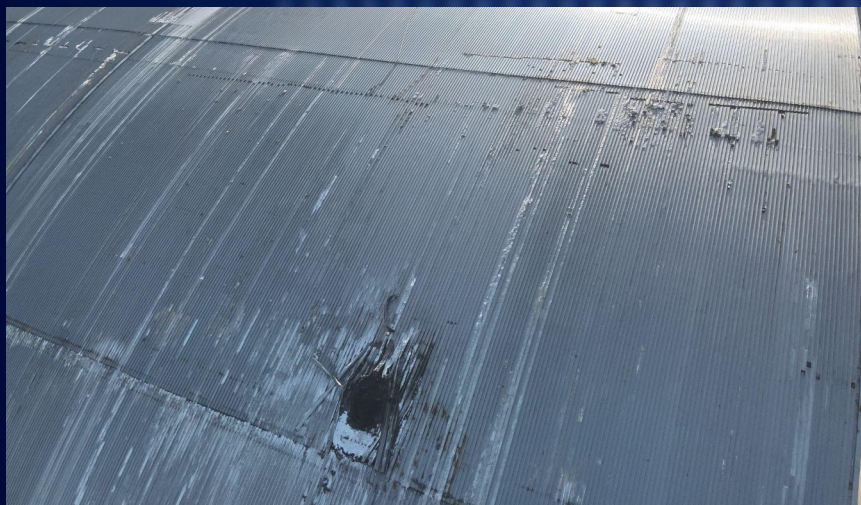
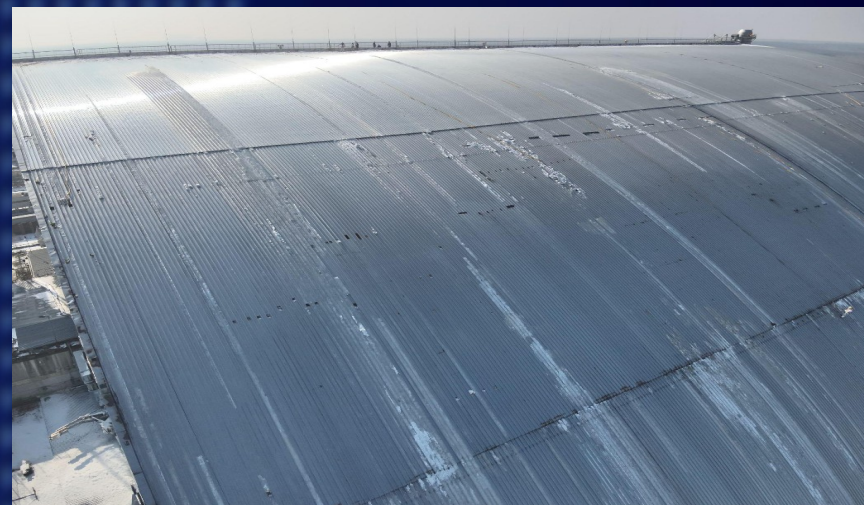
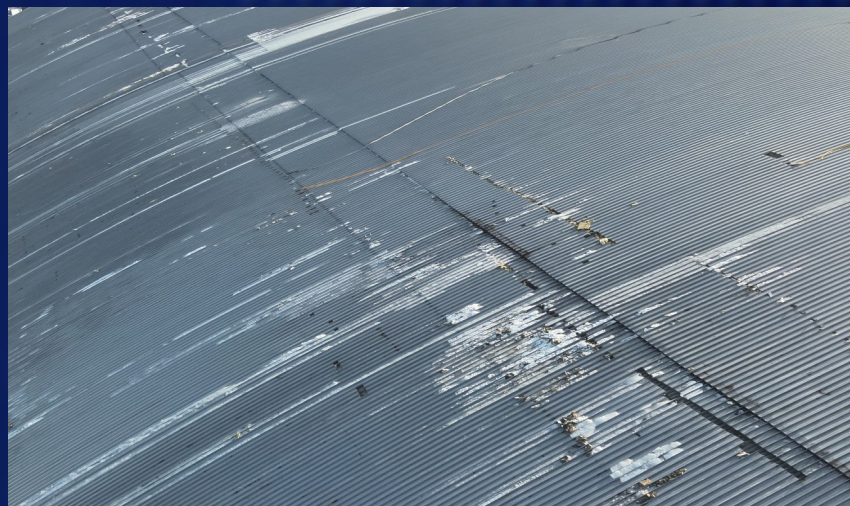
- Збір даних для подальших аналізів та оцінки пошкоджень
